SAFETY ALERT

Electrical workers sustain fatal injuries following switch failure

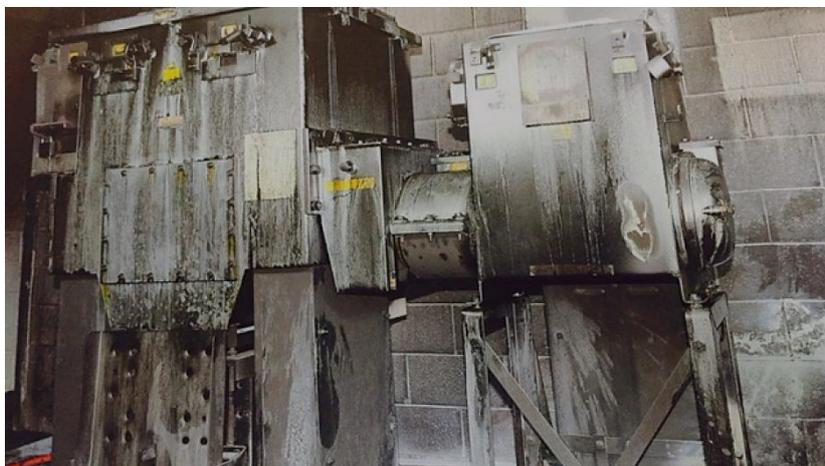
Two electrical workers were killed and two other people suffered serious injuries when a high-current fault occurred in an 11kV oil-insulated combined-fuse switch (CFS) fuse unit that they were maintaining.

Long and Crawford GF3 CFS unit (left) and Ring Main unit (right) involved in the incident.

1. The incoming supply to the CFS unit was not isolated before the workers began work.
2. When the fuse ruptured and consequently disintegrated, material may have been distributed in the tank that aided the development of a short circuit fault.
3. Almost all the insulating oil contained in the fuse tank was vaporised or ejected from the tank during the fault.

Where a mine uses high voltage, oil-filled CFS units, regardless of the type or manufacturer, the mine operator should review and update their high voltage procedures to ensure:

1. Where a fuse has or may have operated that:
 - the switch or earthing mechanism is not operated unless the incoming supply to the CFS unit is isolated and earthed
 - the fuse tank lid of the CFS unit is not opened unless the incoming supply to the CFS unit is isolated and earthed
 - the incoming supply to the CFS unit remains isolated until all work is completed and the fuse tank lid closed.
2. Where other maintenance activities are to be carried out on this type of switchgear:
 - the fuse tank lid of the CFS unit is not opened until it is isolated from the incoming supply
 - the incoming supply to the CFS unit remains isolated until all work is completed.
