SAFETY ALERT

Mine worker injured after falling from grader access ladder

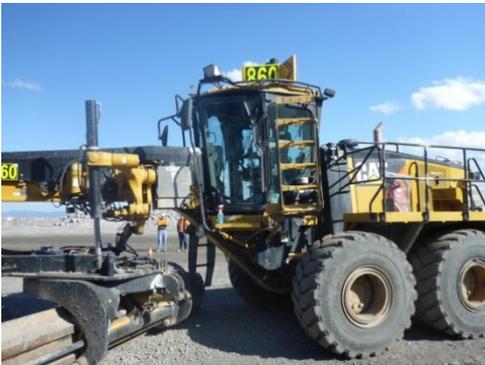
Figure 1: Access ladder in raised position

The operator had parked the machine to clean the windows. He did not shut the machine down. While cleaning the windows he descended the access ladder to a position where he could close the door. When he closed the door, the operator reported that the ladder rotated. As the ladder rotated, the operator became entangled, lifted and fell head-first to the ground. He managed to contact co-workers and was taken by ambulance to hospital where he was diagnosed with spinal injuries. Investigations are continuing.

1. As supplied by the ladder manufacturer, the ladder control system prevents the ladder from being lowered if the park brake is not applied, and automatically raises the ladder if the door is closed and the park brake is released. This second function is intended to prevent damage to the ladder.
2. The system had an additional interlock switch, installed by the grader supplier, on the blade circle to prevent the ladder from lowering if the blade was not in a certain position, again to prevent damage to the ladder. This interlock switch was connected in series with the park brake interlock.

3. As a consequence of the park brake and blade circle interlocks being connected in series, the ladder control system considered the park brake was released when either the blade circle interlock or the park brake interlock turned off.

5. It is believed the operator correctly aligned the blade to allow the ladder to be lowered, however the blade then moved enough for the interlock to turn off while the cab door was open. The ladder control system interpreted this as the park brake being released, and when the worker closed the door, the ladder operated.

1. Mine operators should consider auditing retractable ladder systems installed on mobile equipment to ensure they are installed and operating in accordance with the ladder manufacturer's recommendations.

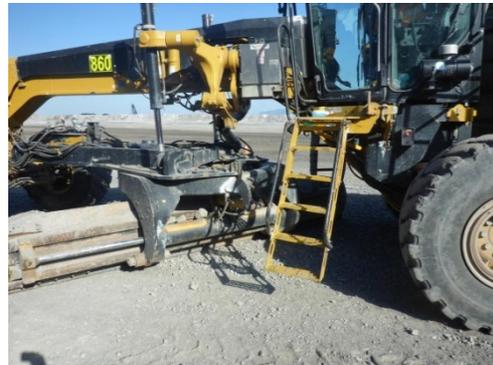
Figure 2: Access ladder in lowered position

4. When the machine was inspected at the incident scene, it was noted the ladder control system was indicating the machine park brake was released, when it was actually applied. The blade had to be slightly adjusted to close the blade circle interlock, allowing the ladder to be operated.
