# MINE SAFETY INVESTIGATION UNIT

INFORMATION RELEASE

## Serious injury

**Incident date** 1 February 2016  
**Event** Worker seriously injured in fall from articulated dump truck  
**Location** Sibelco Salt Ash Sand Plant, Salt Ash, NSW

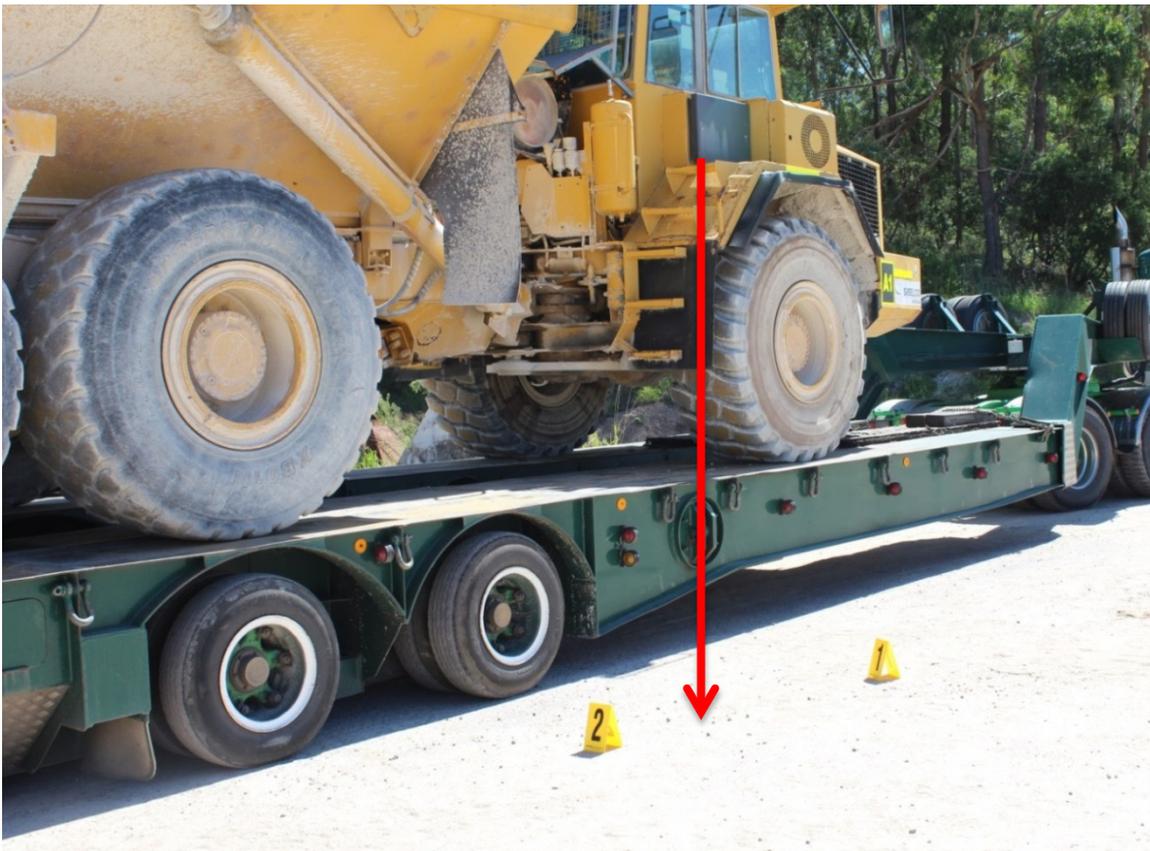
**Photograph of the access ladder provided on the off-side of the Volvo A30 dump truck.  
The red arrow indicates the direction of the fall from the front wheel arch.**

The Volvo A30 dump truck had access grab handles for the steps, and handrails for the platform next to the driver's left side entry door of the cabin. The right side did not have a handrail for the platform, although two grab handles had been installed for the right side access steps.

The plant operator appears to have turned to face the rear of the dump truck and walked to the top access step where he has turned his upper body and reached for the grab handle on his right with his left hand. While twisting to reach the grab handle he has fallen to ground level below the low loader.

The height of the dump truck wheel arch platform to ground level is about 1.8 metres. While on the low loader the height was around 2.7 metres.

A person falling from height from mobile plant is a foreseeable risk and adequate measures should be put in place to control the risk. The provision of safe access equipment on mobile plant is a critical control measure to reduce the risk of falling from mobile plant.

Mine operators must manage the risk of a person falling from one level to another that is reasonably likely to cause injury to that person or any other person.

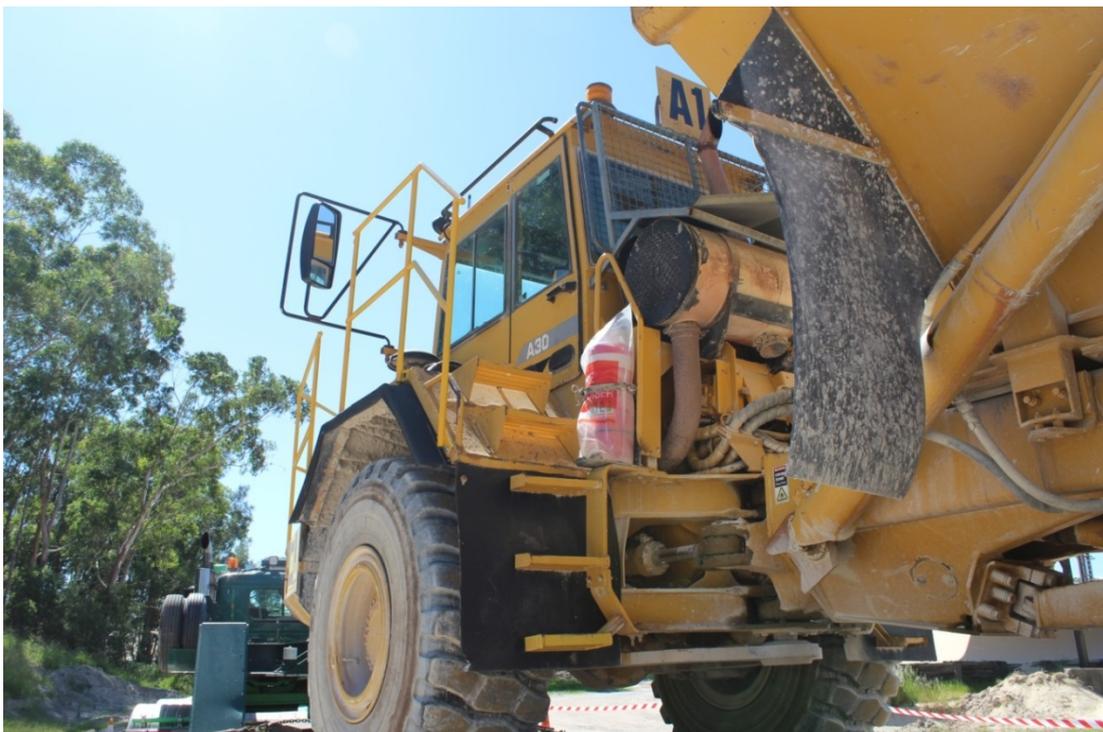
Photograph showing access handrails provided on the driver's entry door side of the Volvo A30 dump truck.
